DEPARTMENT OF TRANSPORTATION**DIVISION OF ENGINEERING SERVICES**

Contract #: 04-0120F4Cty: SF/ALA Rte: 80 PM: 13.2/13.9File #: 69.28**WELDING INSPECTION REPORT****Resident Engineer:**Pursell, Gary**Address:** 333 Burma Road**City:** Oakland, CA 94607**Report No:** WIR-009922**Date Inspected:** 12-Oct-2009**Project Name:** SAS Superstructure**OSM Arrival Time:** 645**Prime Contractor:** American Bridge/Fluor Enterprises, a JV**OSM Departure Time:** 1845**Contractor:** Zhenhua Port Machinery Company, Ltd (ZPMC), Changxing Island **Location:** Shanghai, China

Bay 11, West tower, Lift 2, 55M(Bottom), BC Corner Diagonal Plate.

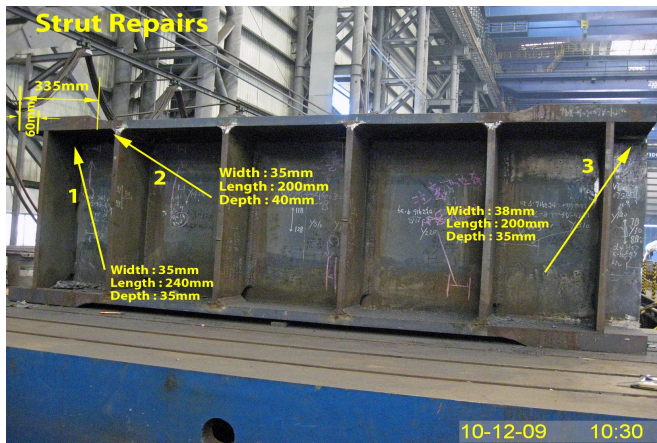
Bay11, West Tower, Struts Repair.

Repair gouge out noticed on strut weld Identified as WD1-A6003-8-7B, 9A. See attached picture for details.
